**APPENDIX B**

**SITE VISIT PHOTOGRAPHS**

**PARCEL 1**

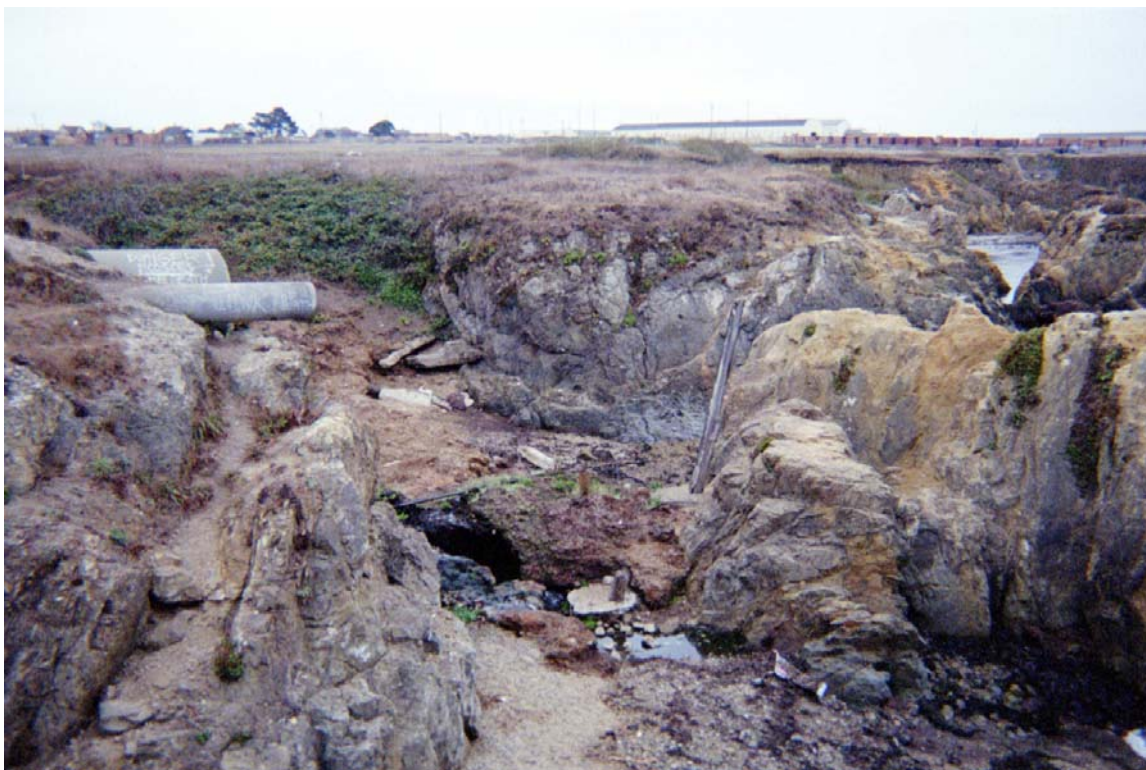
Photo 1. William J. Blinn Trust Site – North of G-P Property.

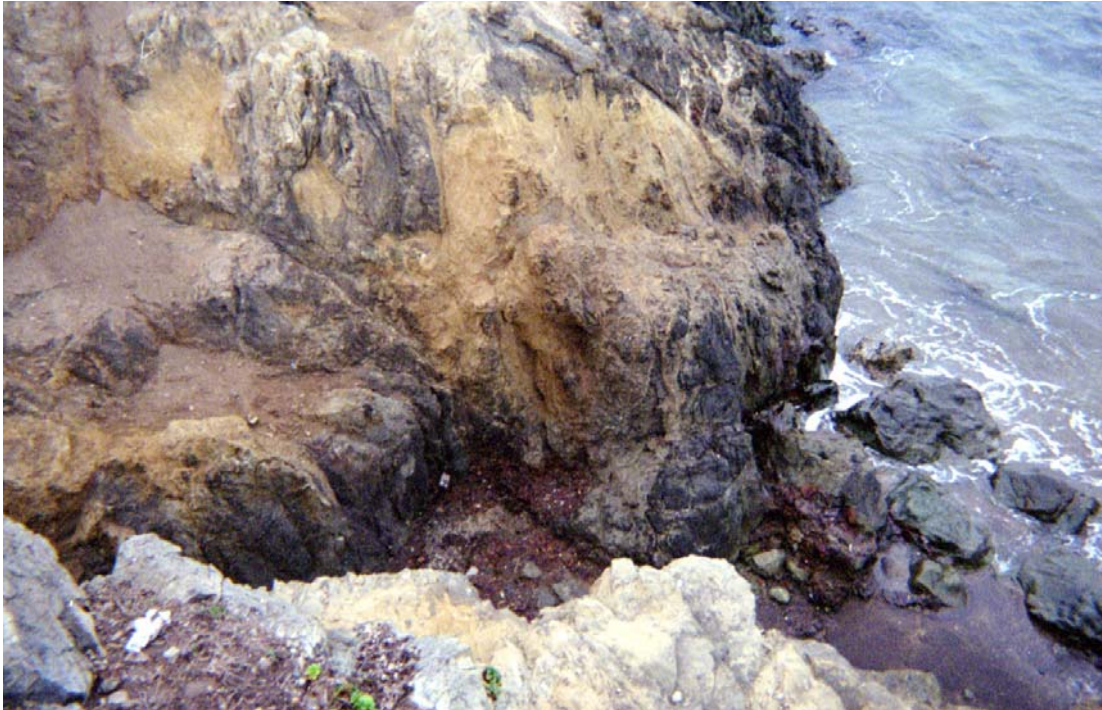
Photo 3. Glass Beach #1.

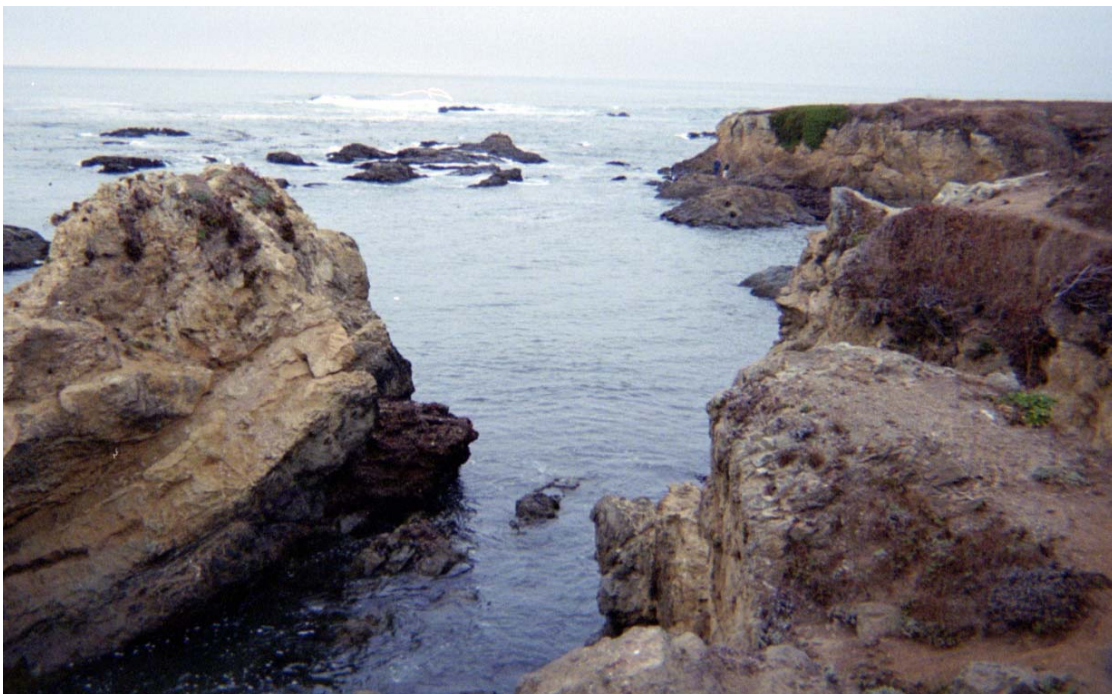
Photo 4. Glass Beach #1.

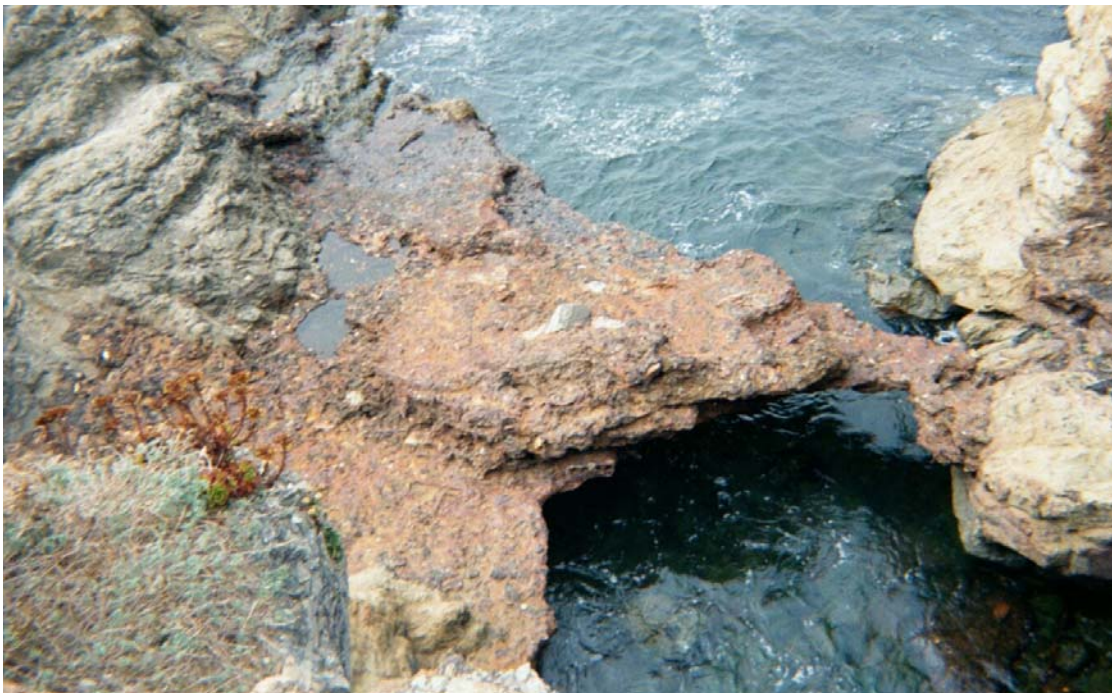
Photo 6. Glass Beach #2.

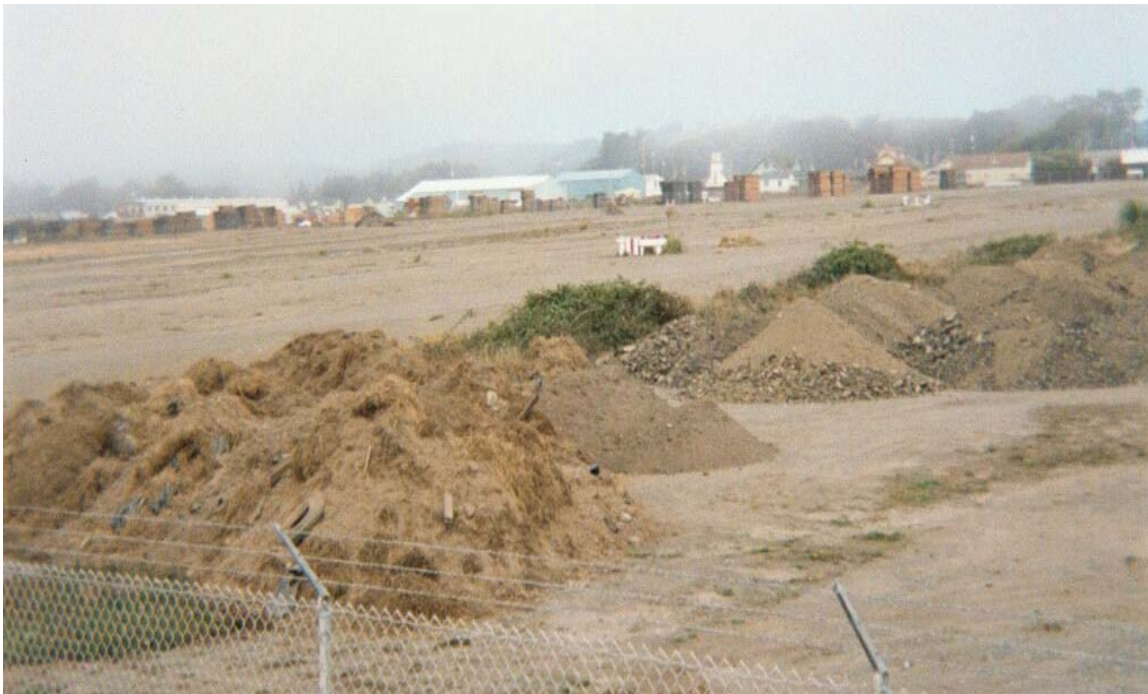
Photo 8. Soil Stockpiles on property leased by Pacific Marine Farms. Stockpiles have been removed.

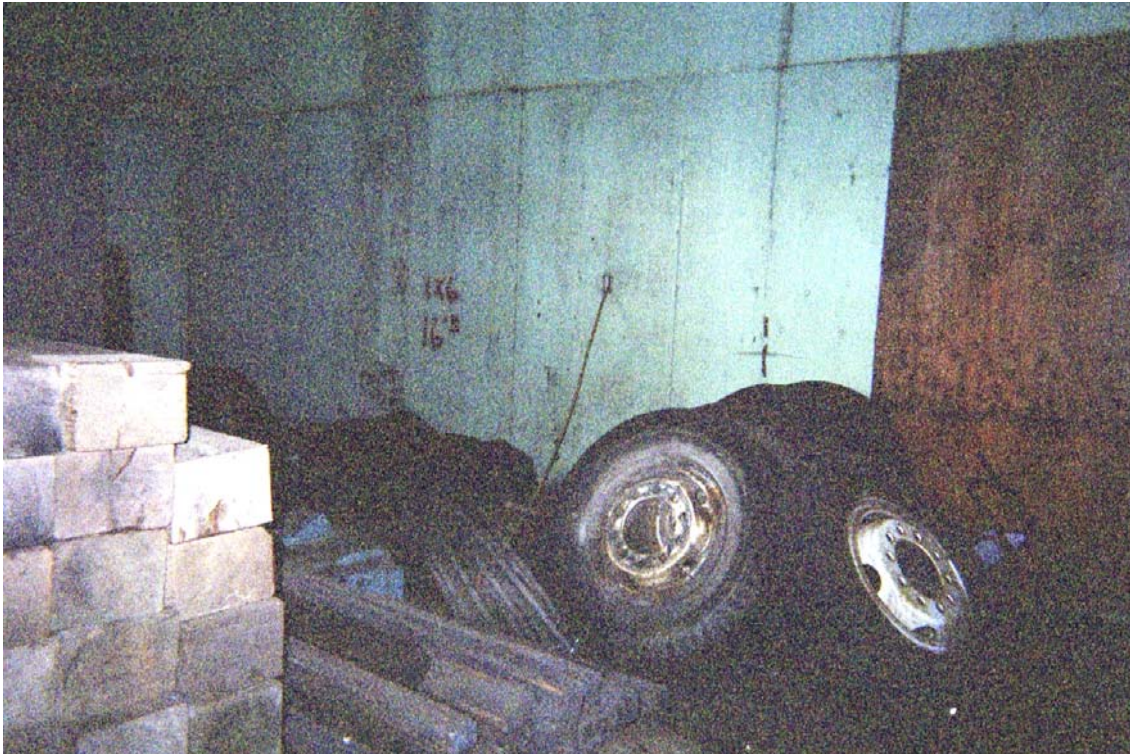
Photo 1. Breezeway – Southeast Corner. Debris has been removed.

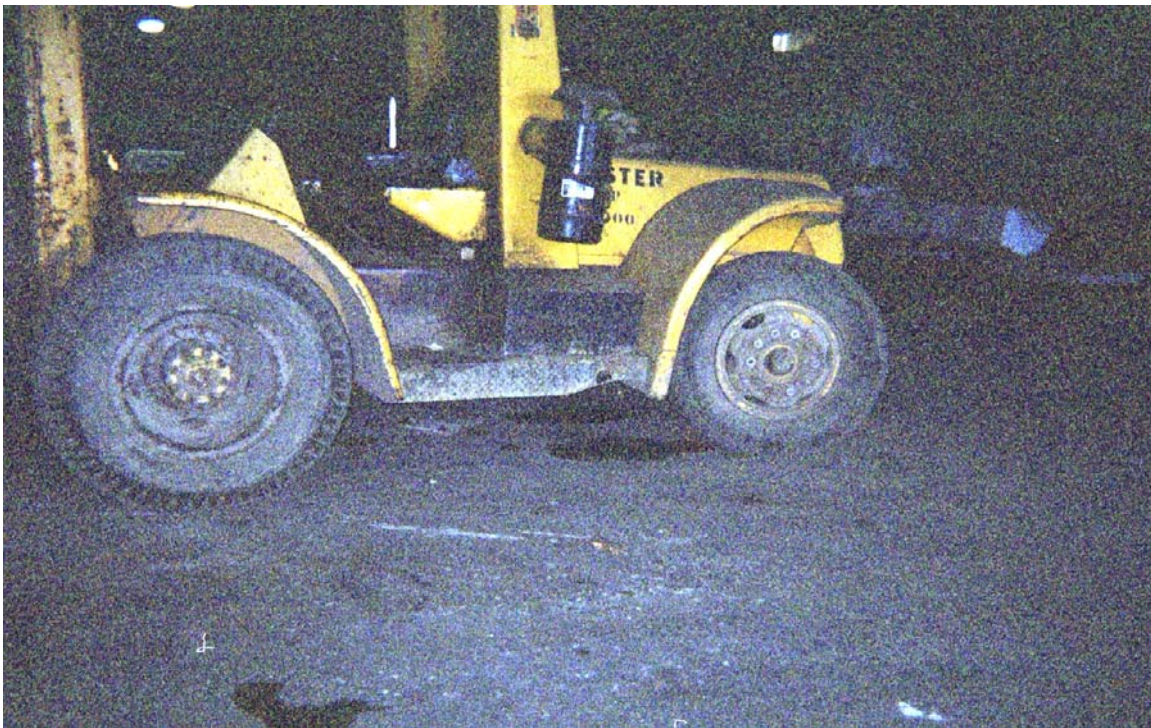
Photo 2. Storage Shed #2 – Surface stains underneath and around equipment.

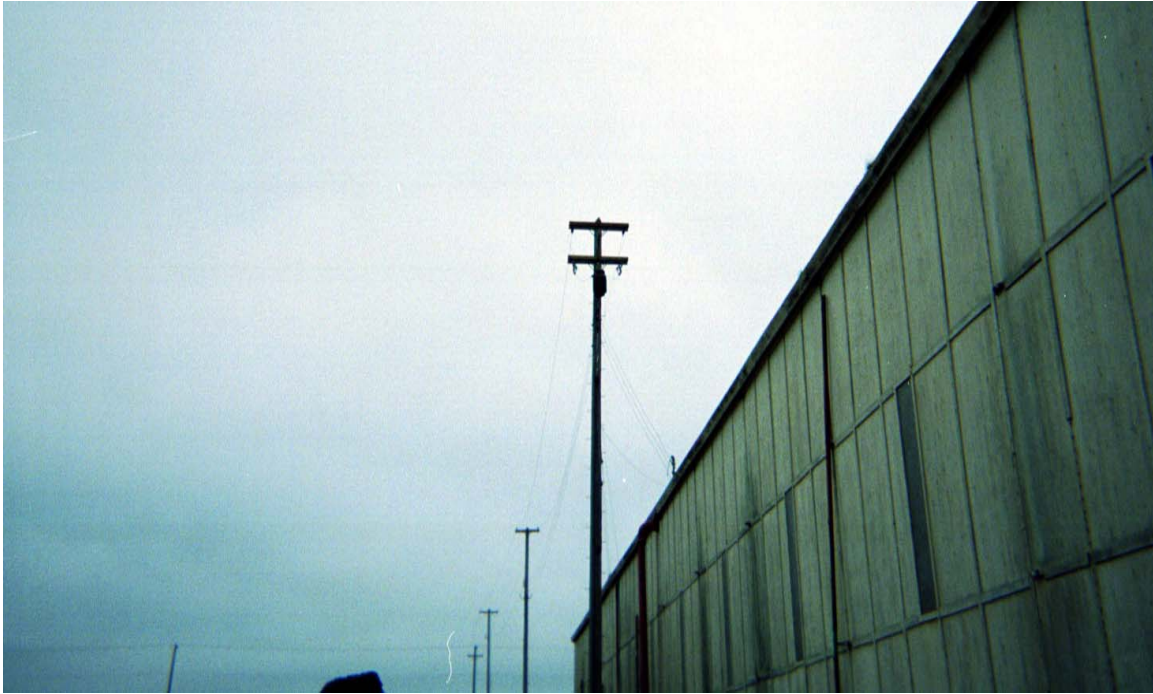
Photo 3. Overhead transformer – Parcel 2.

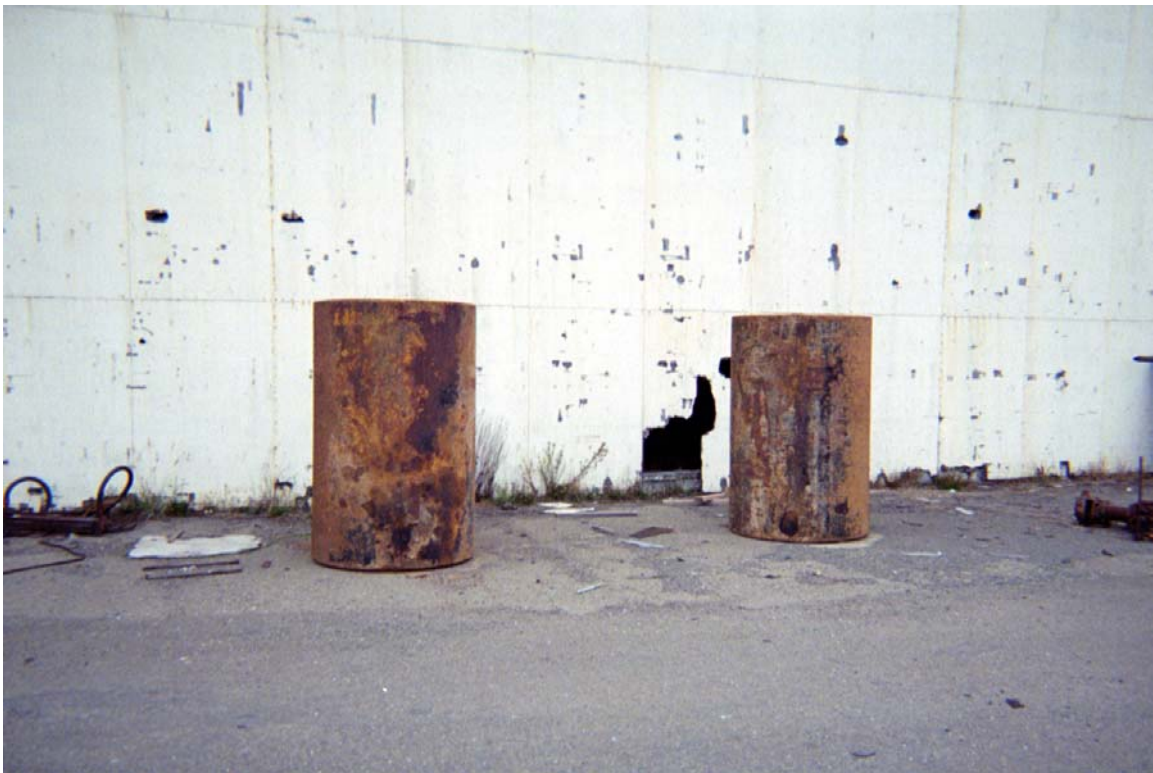
Photo 4. Former USTs East of Storage Shed #2. USTs have been removed.

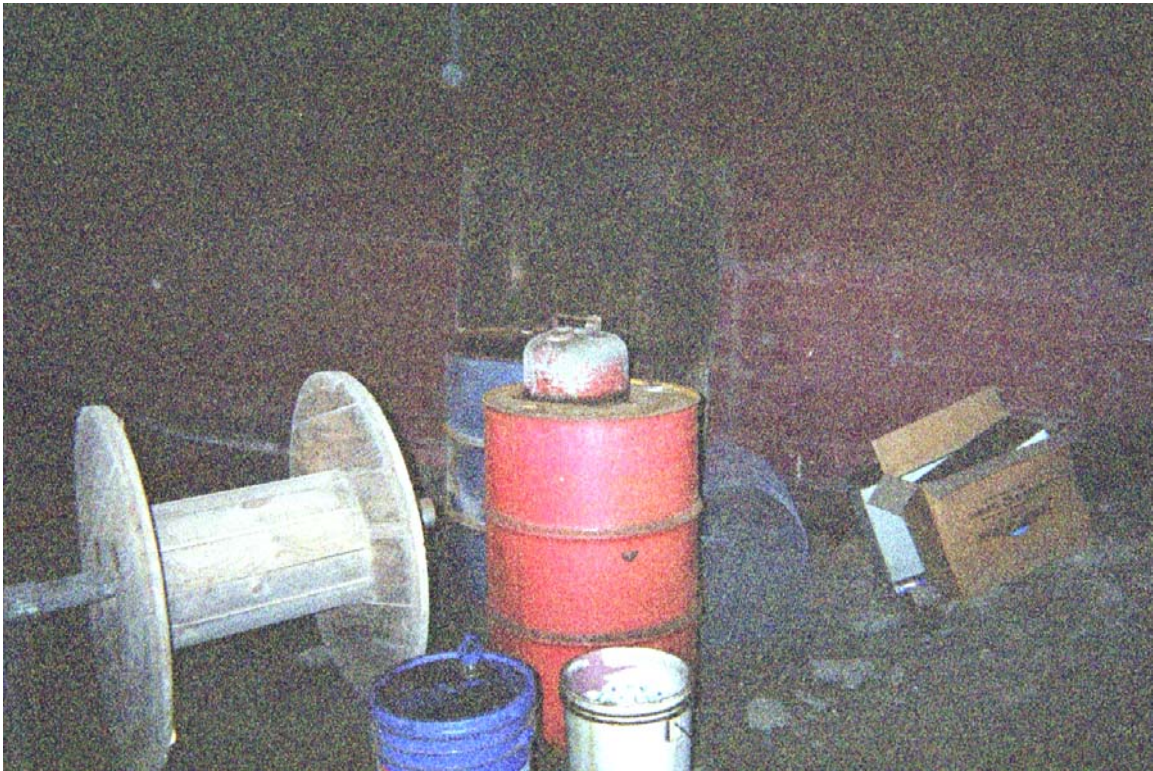
Photo 5. Drums and motor oil containers in Dowel Loc. Drums and motor oil containers have been removed.

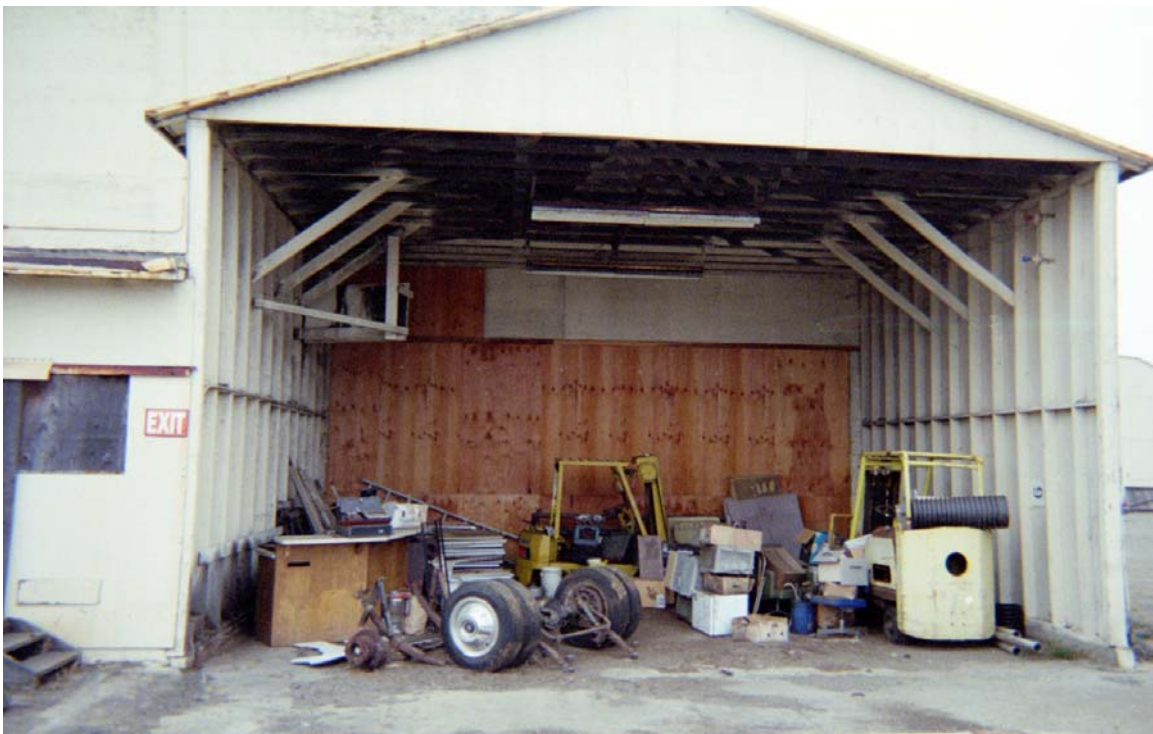
Photo 6. Debris pile east side of Dowel Loc. Debris pile has been removed.

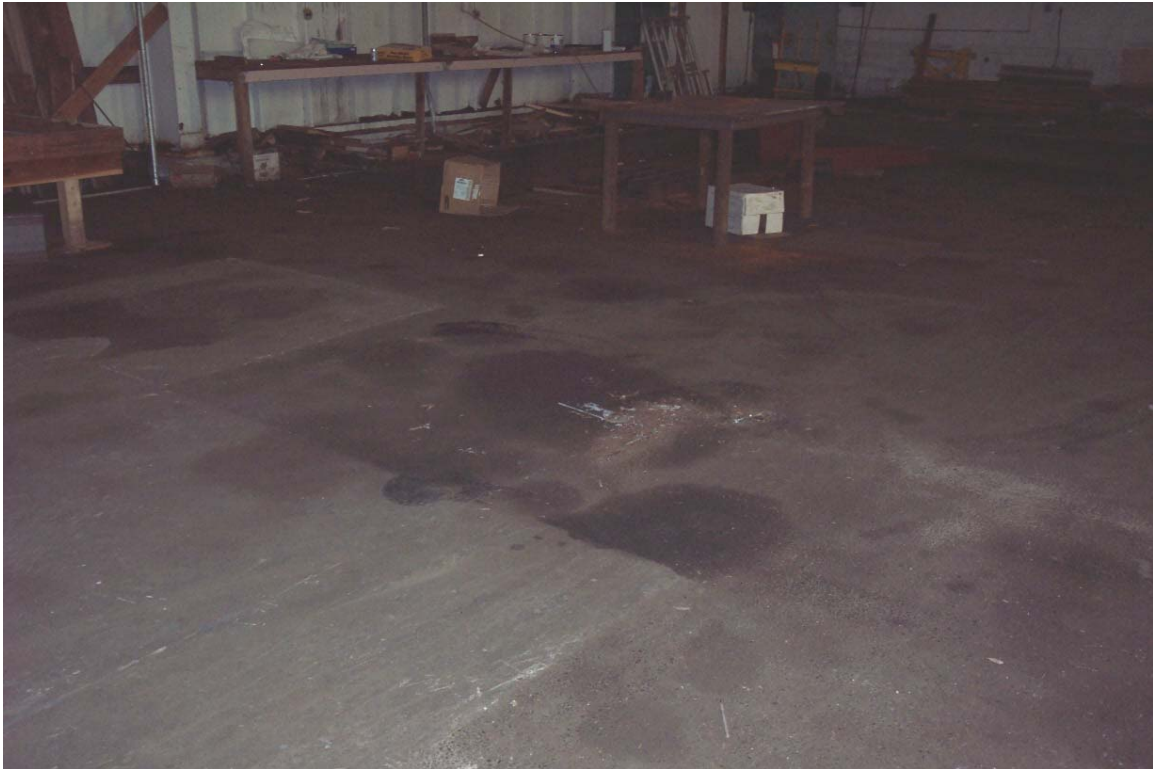
Photo 7. Surface staining on concrete in Glue Lam.

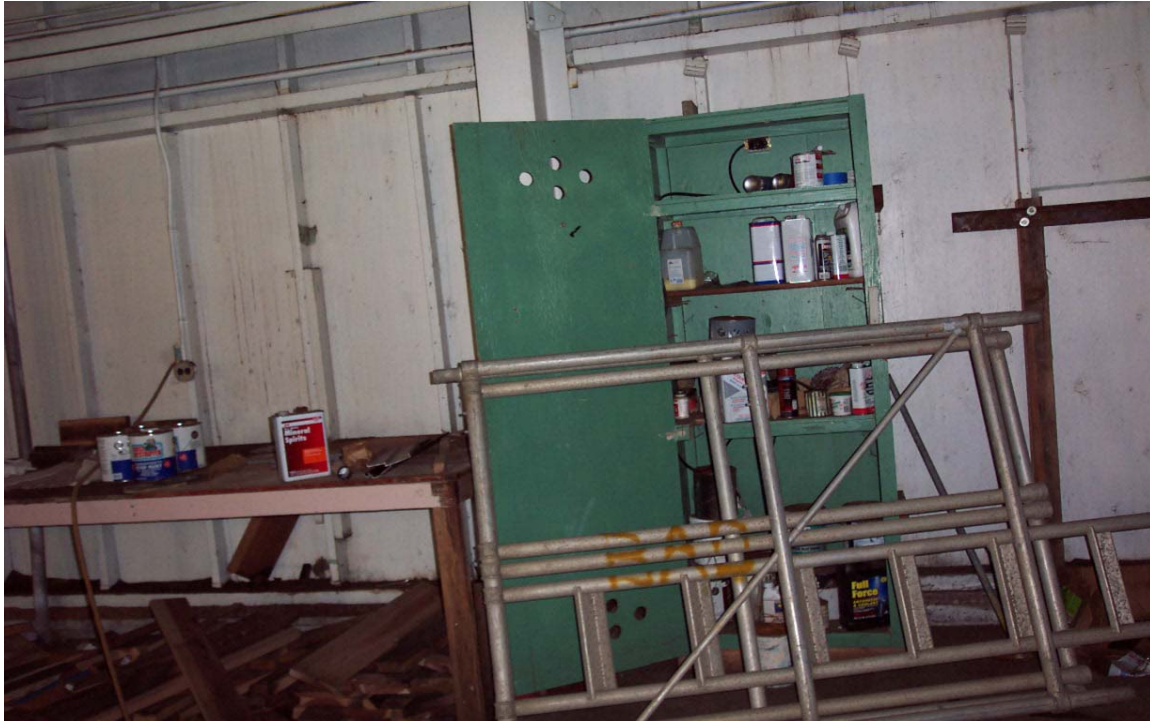
Photo 8. Cabinet and table northeast corner of Glue Lam. Cabinet and table have been removed.

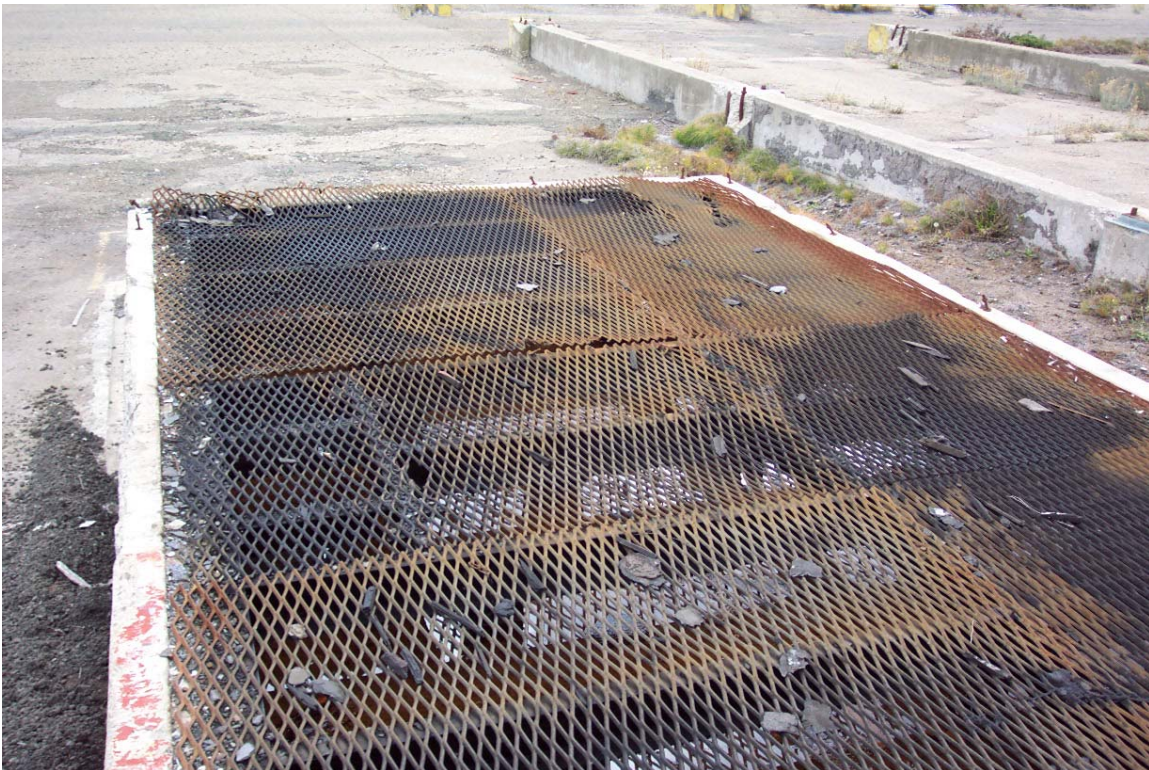
Photo 4. Former oil drum storage containing residual liquid in Former Planer No. 1 area. Liquid has been removed.

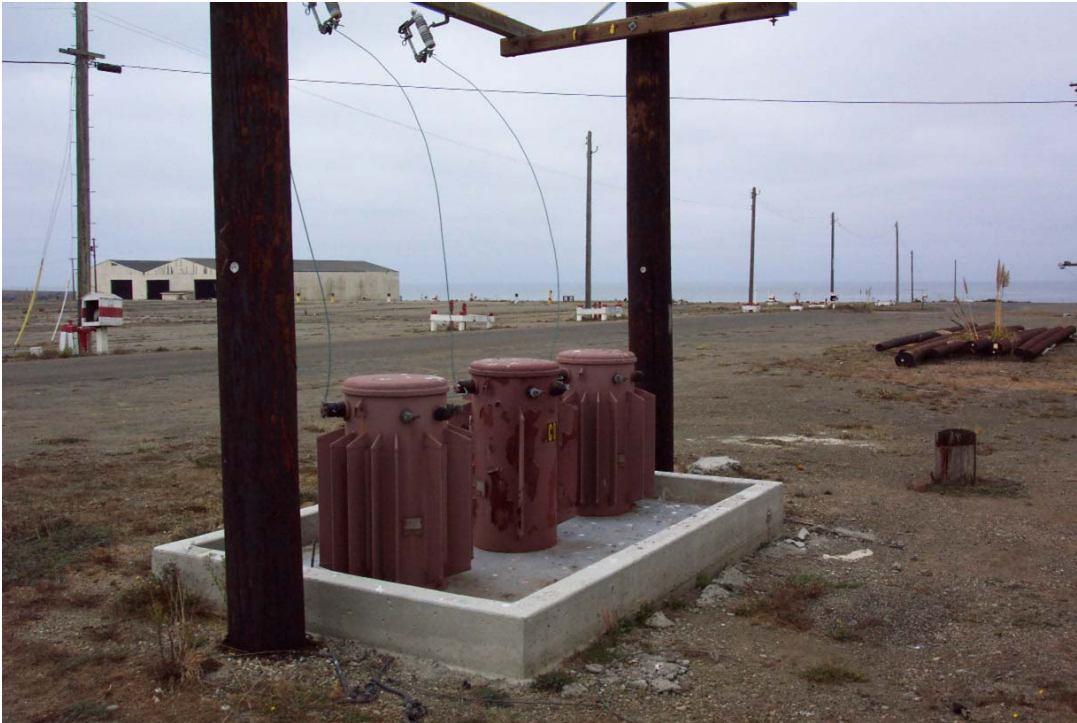
Photo 5. One of two transformer pads north of Former Planer No. 1.

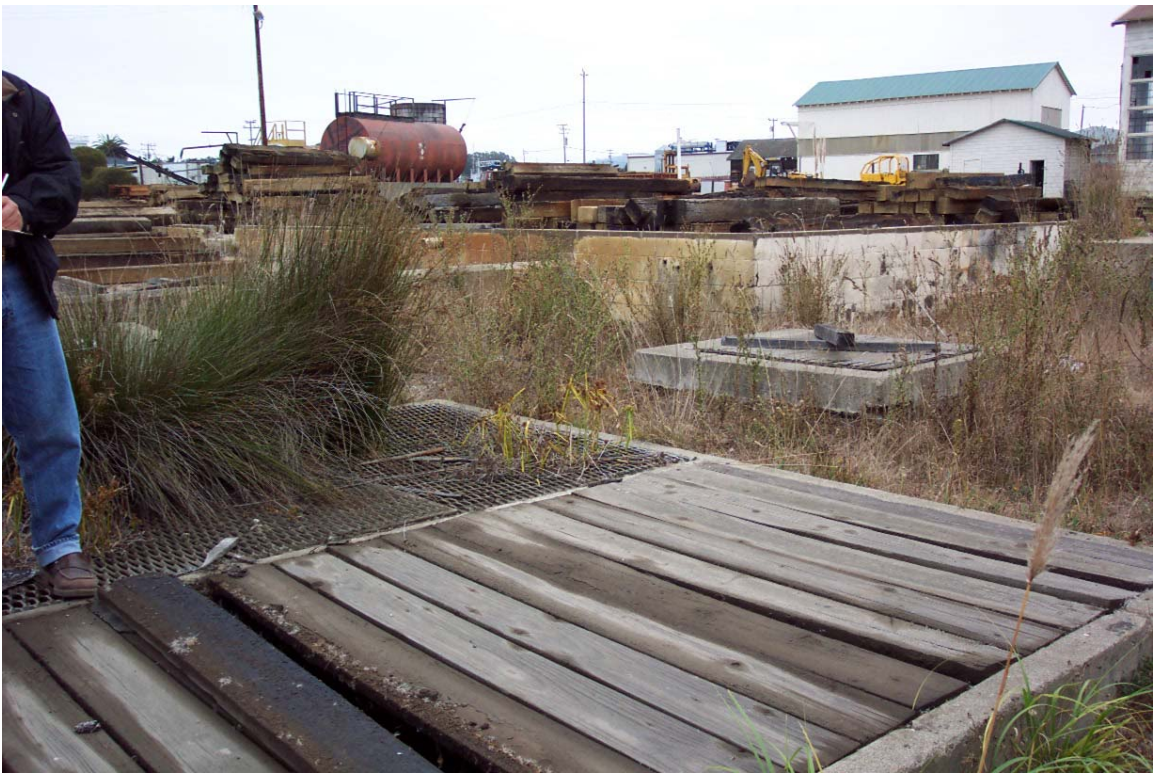
Photo 8. Catch basin (foreground) and sump (background) south of Former Mobile Equipment Shop.

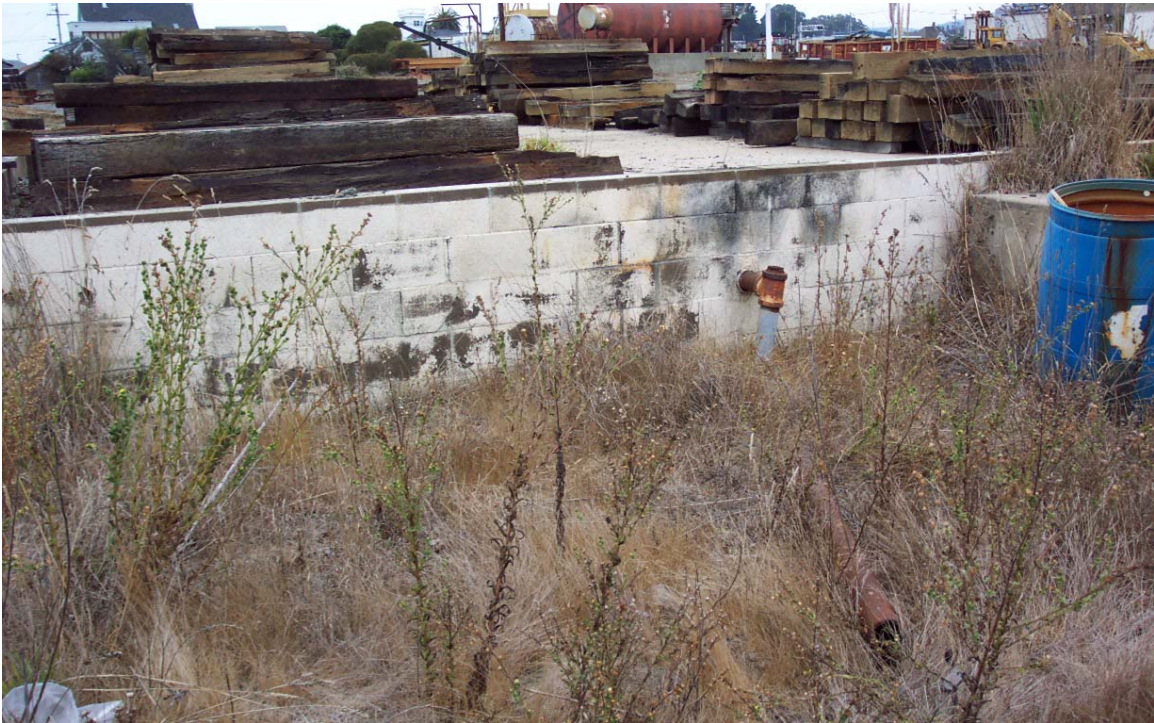
Photo 9. Building foundation and metal pipe with hydrocarbon odor at Former Mobile Equipment Shop.

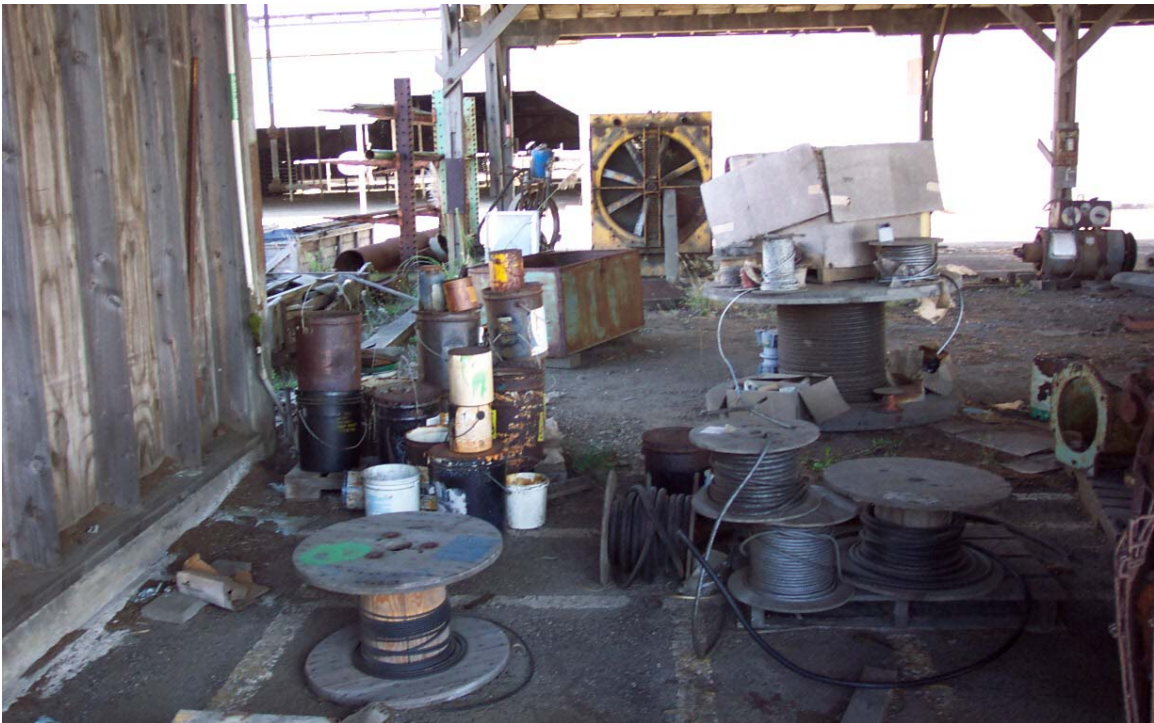
Photo 10. Open storage area in Construction Engineering. Debris has been removed.

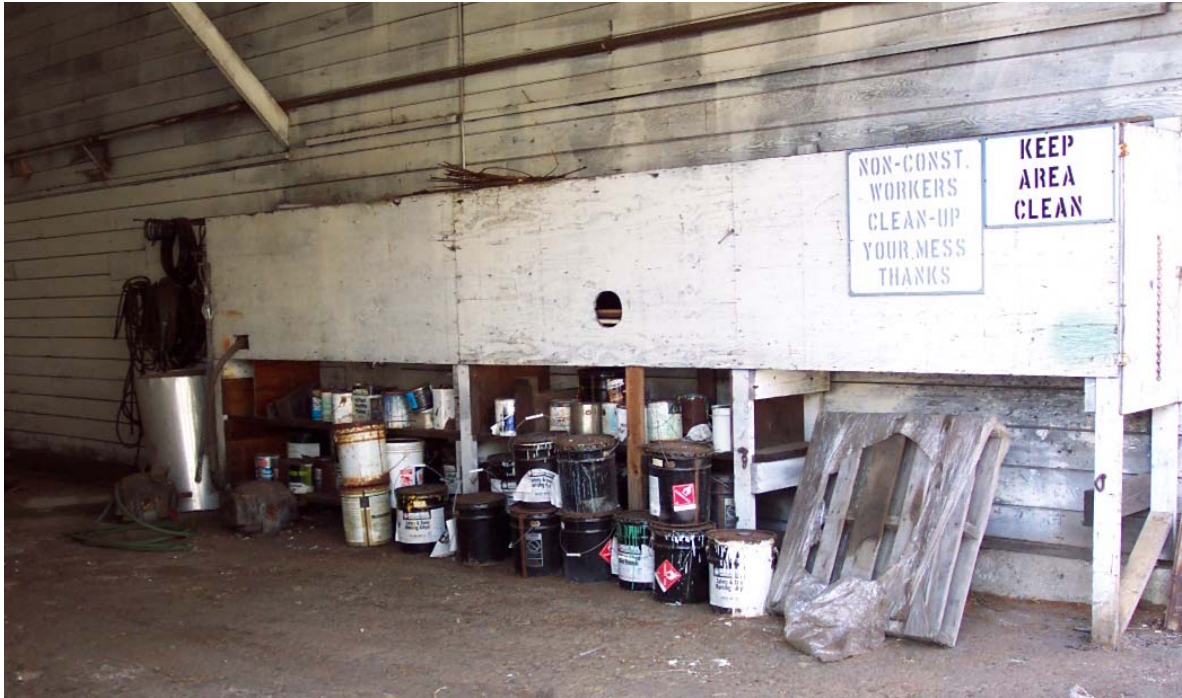
Photo 11. Paint storage in Construction Engineering. Paint supplies have been removed.

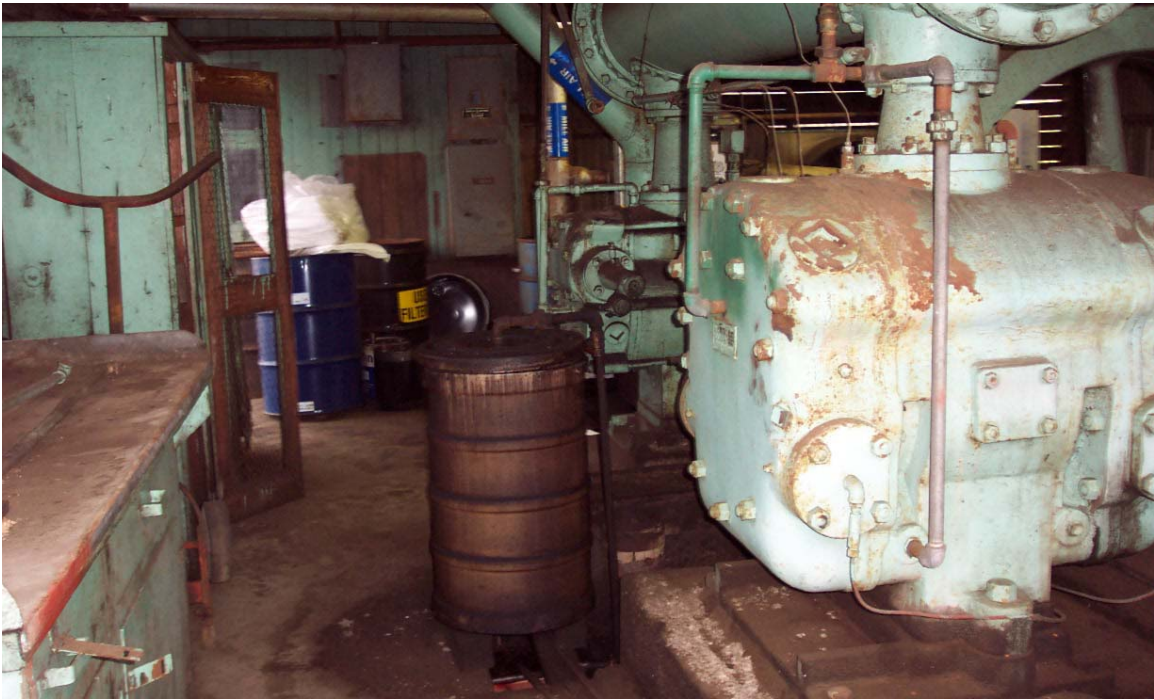
Photo 13. Air compressor and several drums in Compressor House 1. Air compressor and drums have been removed.

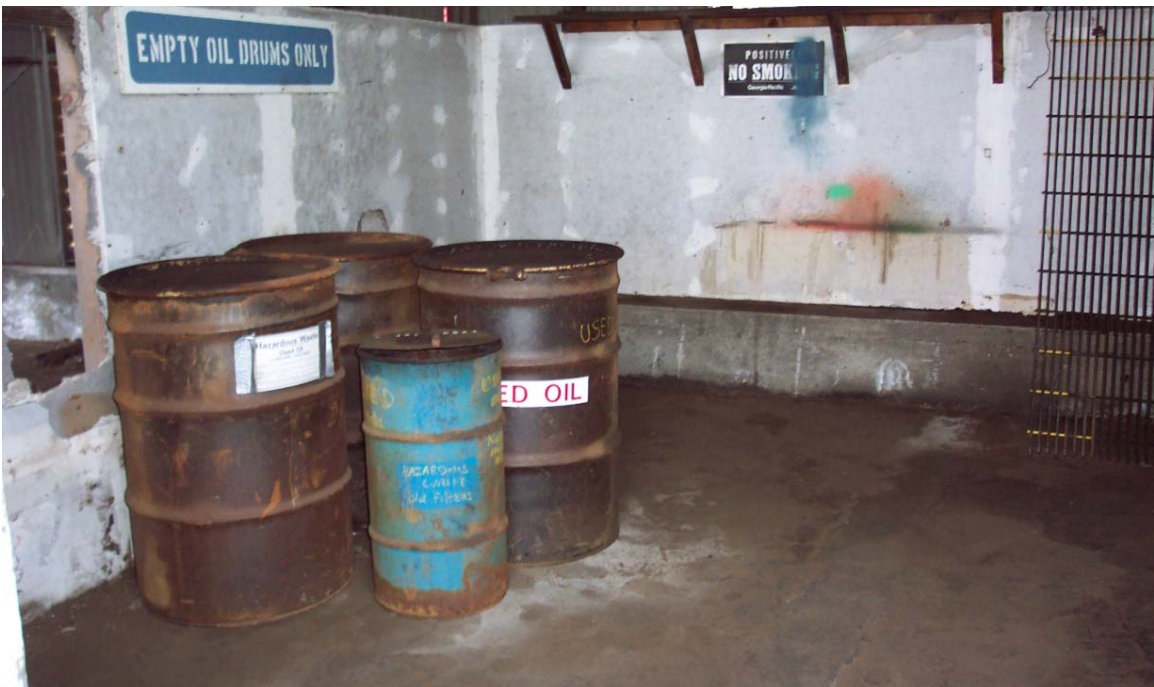
Photo 14. Oil storage in Compressor House 2. Oil and containers have been removed.

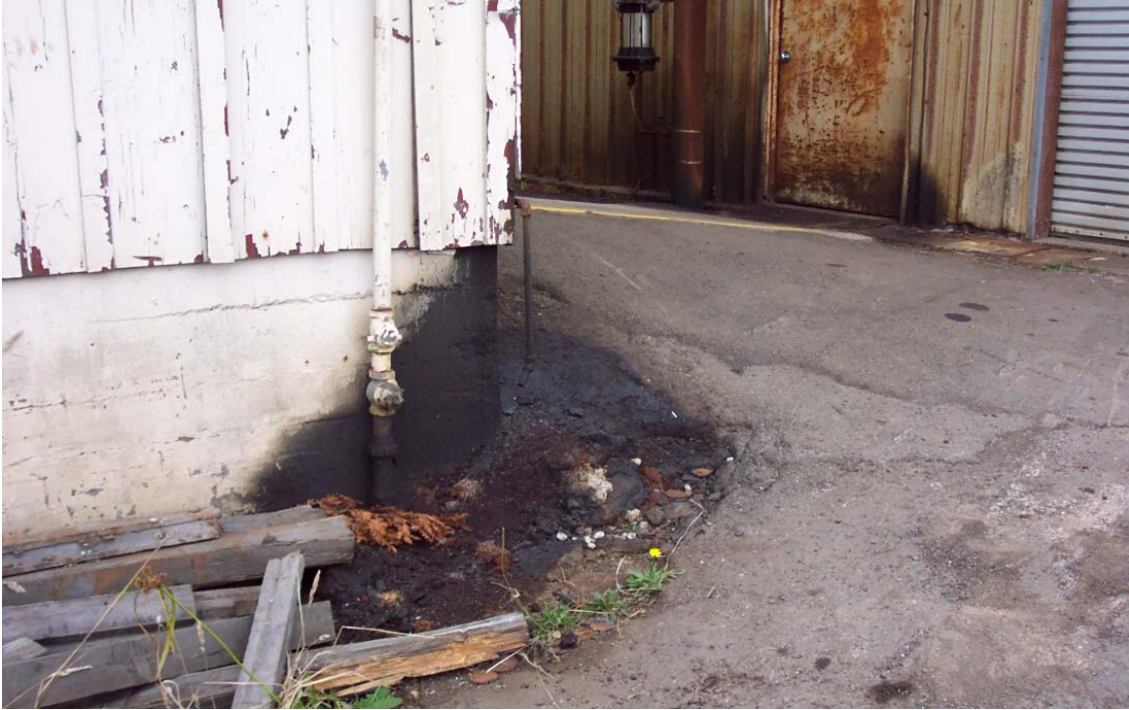
Photo 15. Staining from air compressor lines outside Machine Shop (foreground) and Sheet Metal/Plumbing building (background).

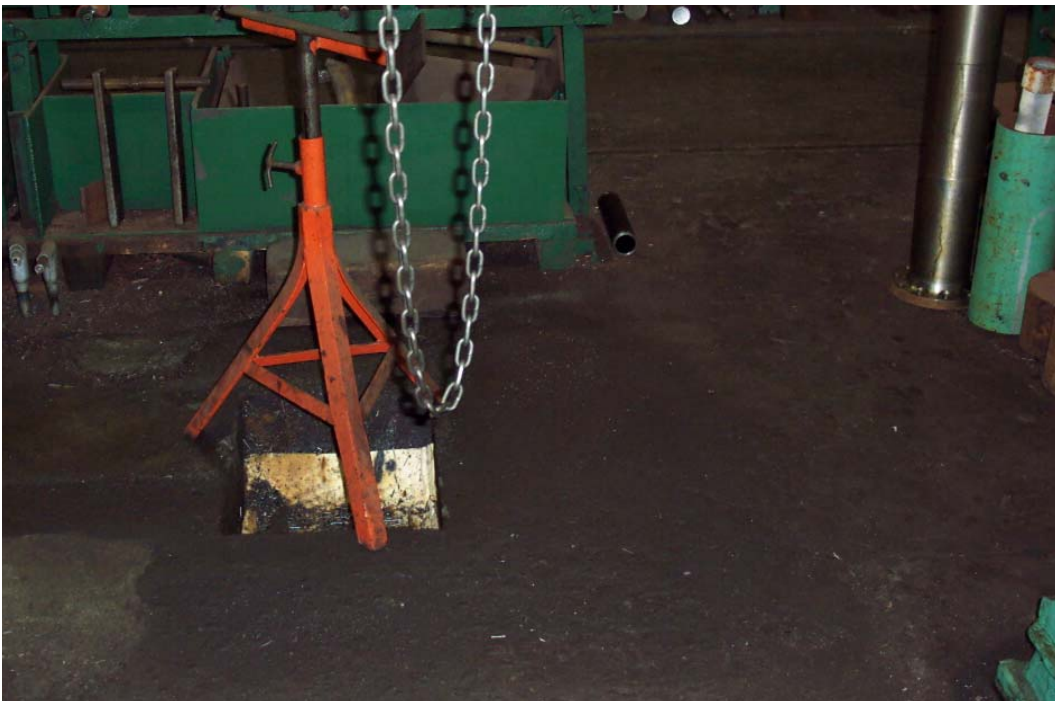
Photo 16. Sump no longer in use at Machine Shop.

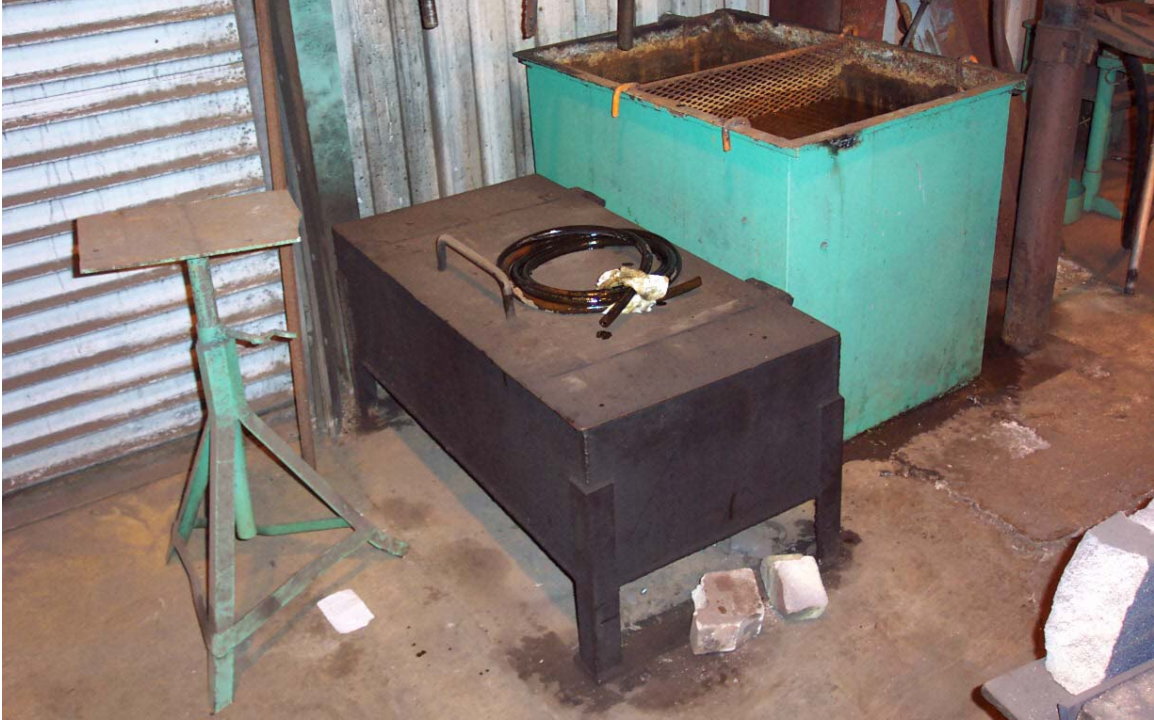
Photo 17. Oil storage in metal container in Sheet Metal/Plumbing.

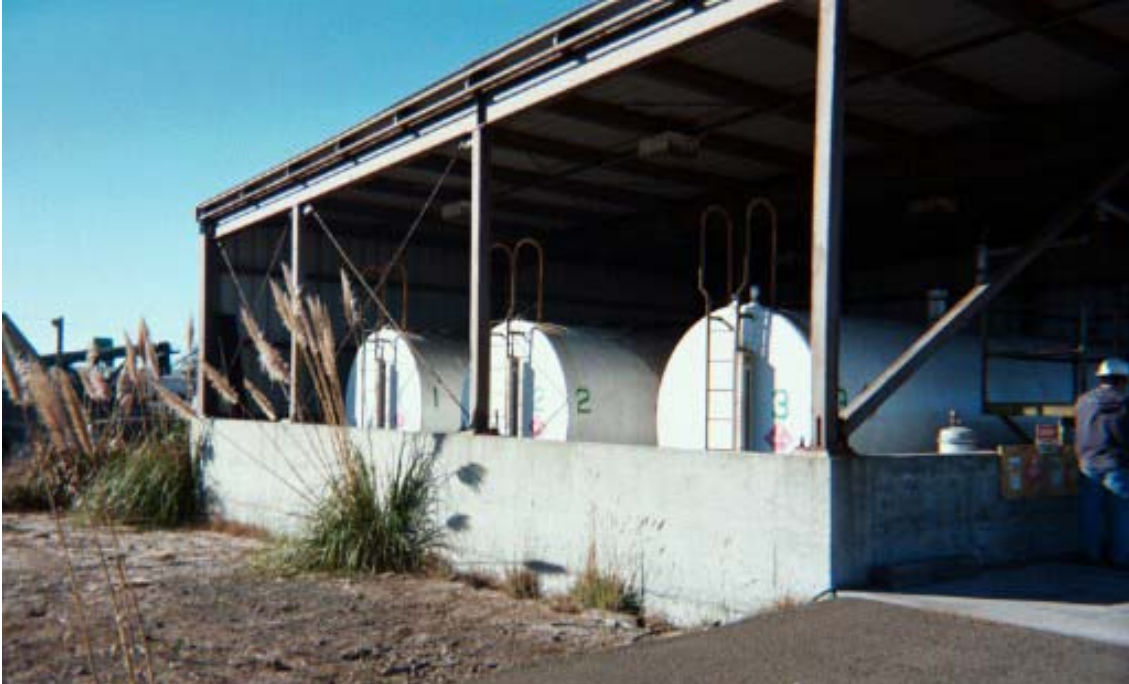
Photo 1. Three 10,000-gallon reserve fuel tanks at the power house fuel storage shed. Fuel tanks have been removed.

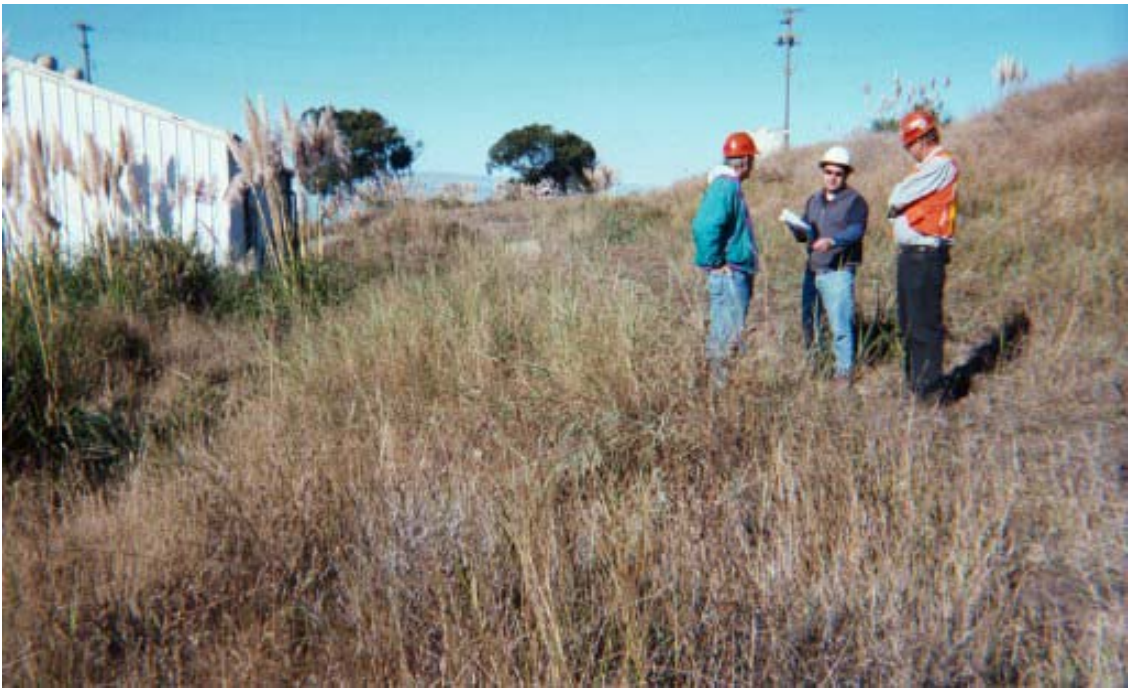
Photo 2. Location of former bunker fuel oil ASTs and associated railroad tracks. Note the water treatment plant on the left hand side.

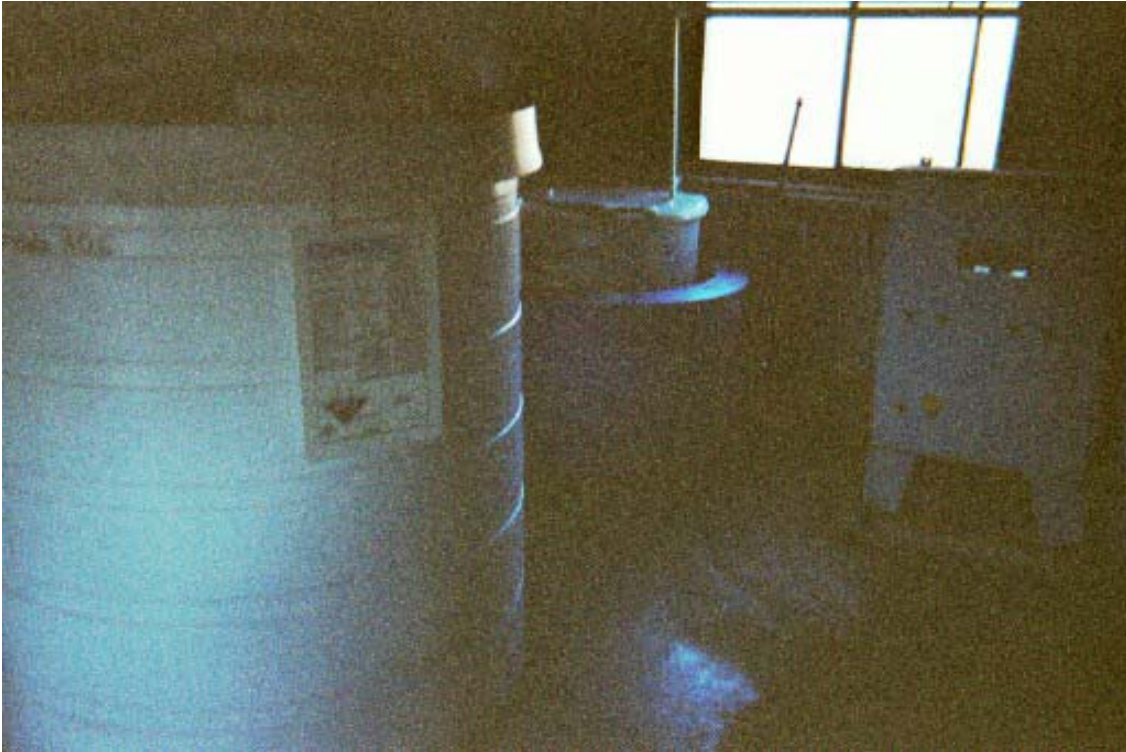
Photo 3. Chemical tanks (sodium hypochlorite and alum) in water treatment plant. Tanks have been removed.
